# The Tacoma Narrows Bridge: Structural Failure Research

Varnit P. Dhanani

## ABSTRACT

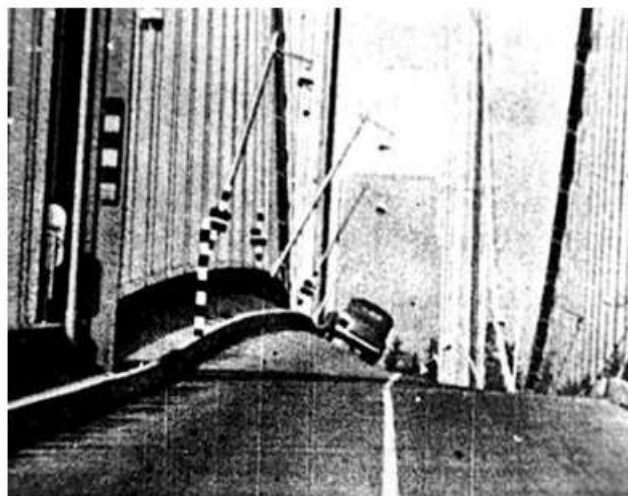
Fig. 5: Gertie twisting (Source: GHPHSM, Bashford 2784)

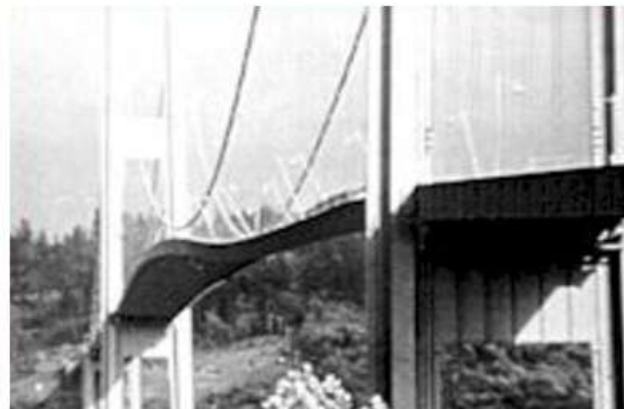
Fig. 6: Bridge Twisting (Source: GHPHSM, Bashford 2784)

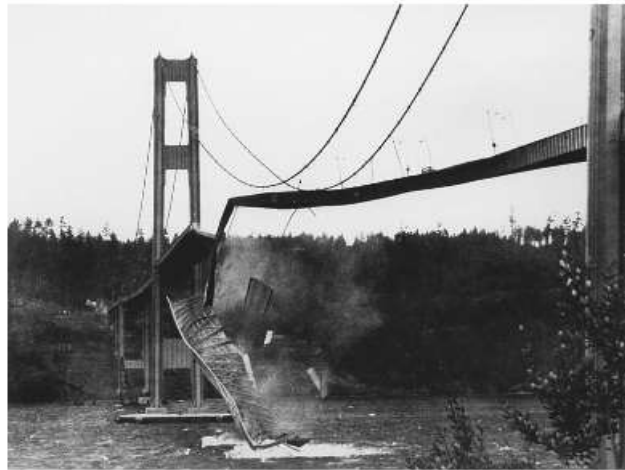
**Fig. 7: On November 7, 1940, the bridge's core section collapsed into the strait below. (Source: Wikipedia)**

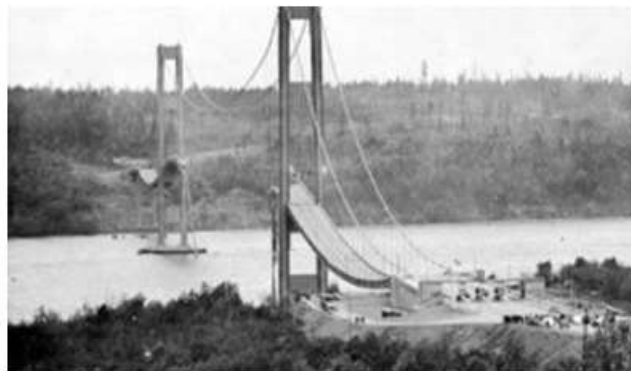
**Fig. 8: Collapse complete (Source: [www.structuremag.org](http://www.structuremag.org))**

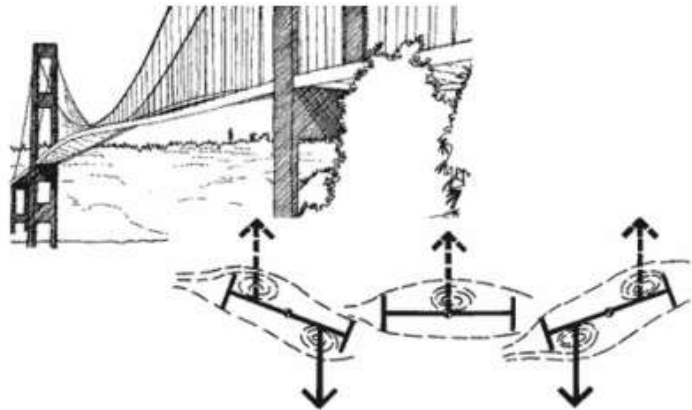
The collapse of Galloping Gertie is largely due to "torsional flutter." It is going to be useful to break this complicated chain of events down into several sections. The key points of the explanation are highlighted below.

2) At ten a.m. on November 7, 1940, a major event occurred. In the middle position of the north cable, the cable band slipped. So, the wire got separated into two unequal parts. Consequently, the bridge deck twisted instead of switching as a result of vertical displacement.

3) The torsional motion of the bridge deck was influenced by "vortex shedding." In brief, the Narrows Bridge got vortex shedding as follows: The wind split when it hit the eight-foot solid plate girder supporting Galloping Gertie's deck.

- The stress caused the bridge deck to twist. Although the steel is elastic, the twisting caused a greater wind flow separation. This whirled up a vortex or wind force, raising and twisting the deck even further.
- The deck construction would not lift or twist. It was naturally tempted to revert to its original shape. It came back with the same speed and direction as the lifting force. In simple terms, it moved "in phase" with the vortex. Afterwards, the wind sped up this movement. As a result, a "lock-on" event was produced.

**Fig. 9: Tacoma's Failure Mechanism (Source: original sketch contributed by Allan Larsen)**

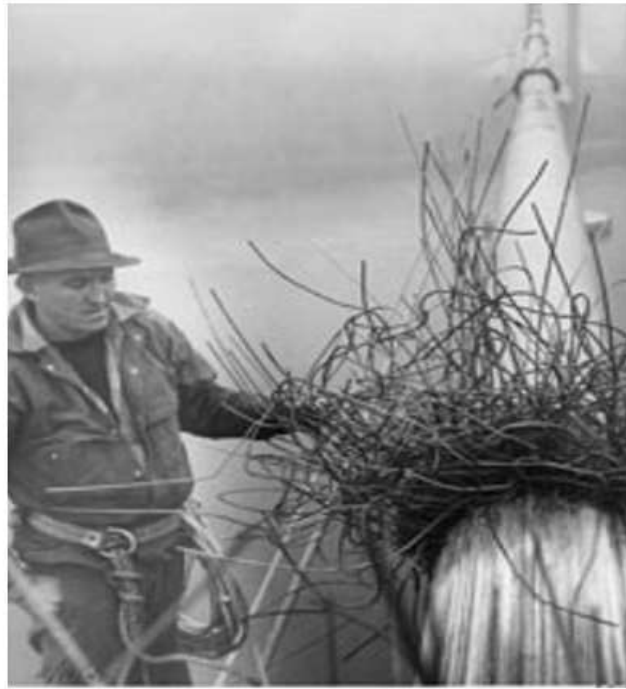
When the collapse occurred, the main suspension cables were ejected sideways, twisted, and thrown approximately 100 feet into the air. They were released from their positions at the

**Fig. 10: A bridge inspector examines Damaged cable (Source: WSDOT)**

cable saddles on each tower and fell heavily on the approach spans. Due to slippage of the cable band, approximately 350 wires of the north cable at mid-span were destroyed, and other cables were found to be under significant stress and deformation. Even though the main wires were completely destroyed, recovery work took place, but they were only worth being scrap metal.

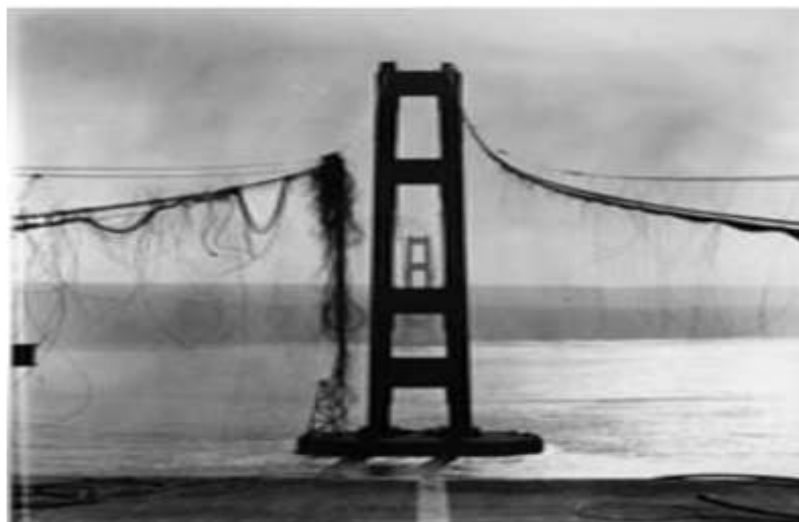
All of the bracing struts were bent and twisted in addition to the main towers. When subjected to excessive stress, the metal warped and could not return. Now they comprehend that the entire scrap metal had value.

**Fig. 11: View of broken wires and towers, facing west, February 1943. (Source: WSDOT)**

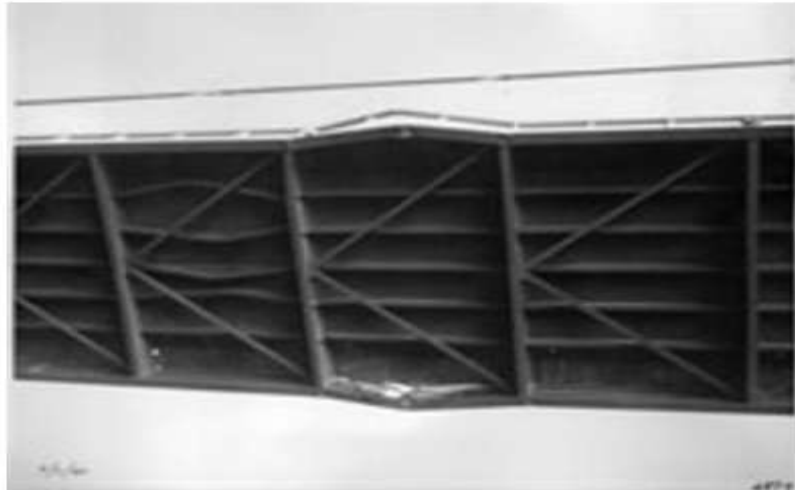
**Fig. 12: View from underneath the deck of buckled steel beams. (Source: WSDOT)**

Substantial damage was caused by the core losing its strength first and the side spans collapsing. The events put stress and some twisting on the plate girders and floor beams. Some of them buckled beyond repair.

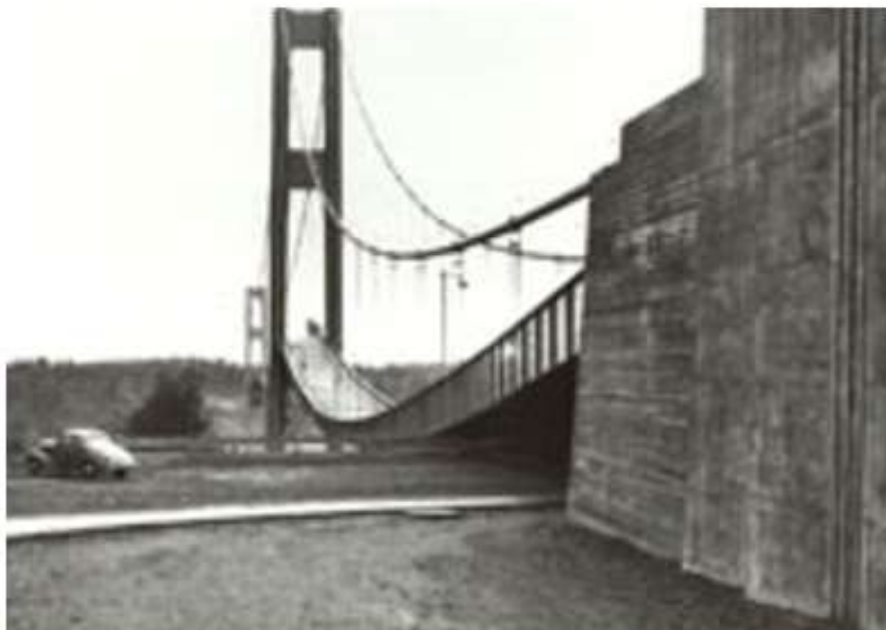
**Fig. 13: M3-5: Sagging east side stretch (Source: GHM, Bashford 2795)**

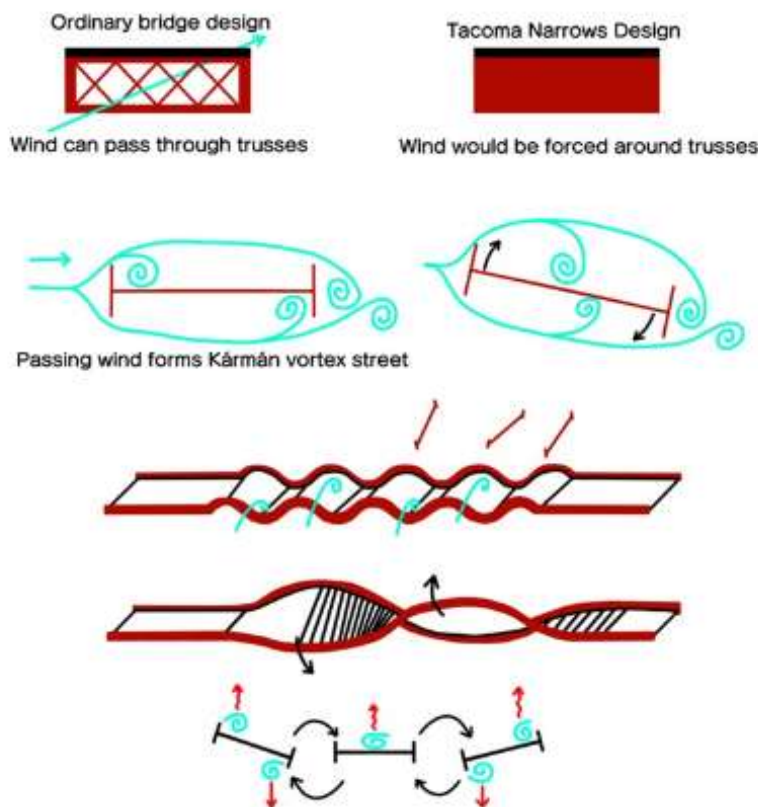
Fig. 14: A simplified illustration of the Tacoma Narrows Bridge's collapse (Source: Wikipedia)
